# IN-SERVICE PERFORMANCE AND COSTS OF METHODS TO CONTROL URBAN RAIL SYSTEM NOISE

## SECOND TEST SERIES REPORT

INTERIM REPORT

U.S. DEPARTMENT OF TRANSPORTATION  
URBAN MASS TRANSPORTATION ADMINISTRATION  
Office of Technology Development and Deployment  
Office of Rail and Construction Technology  
Washington DC 20590

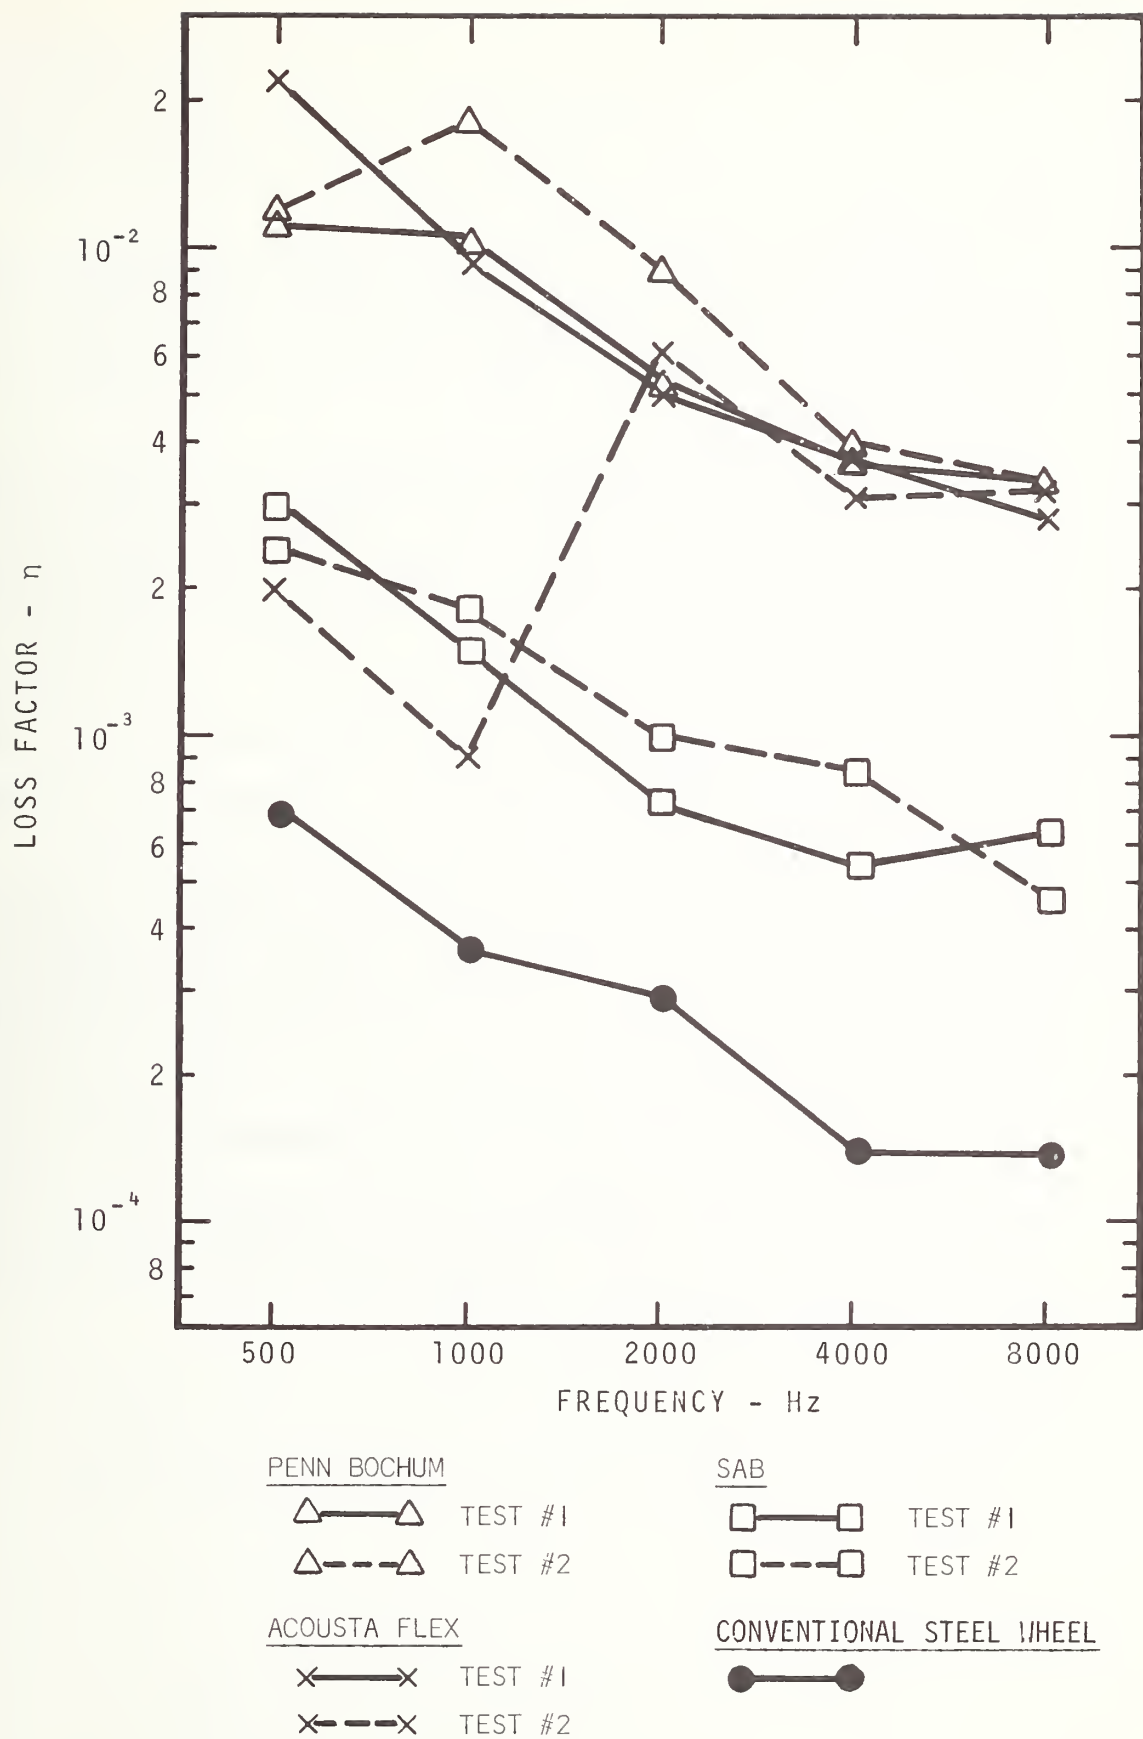
FIGURE 6-5. LOSS FACTORS FOR THE RESILIENT WHEELS

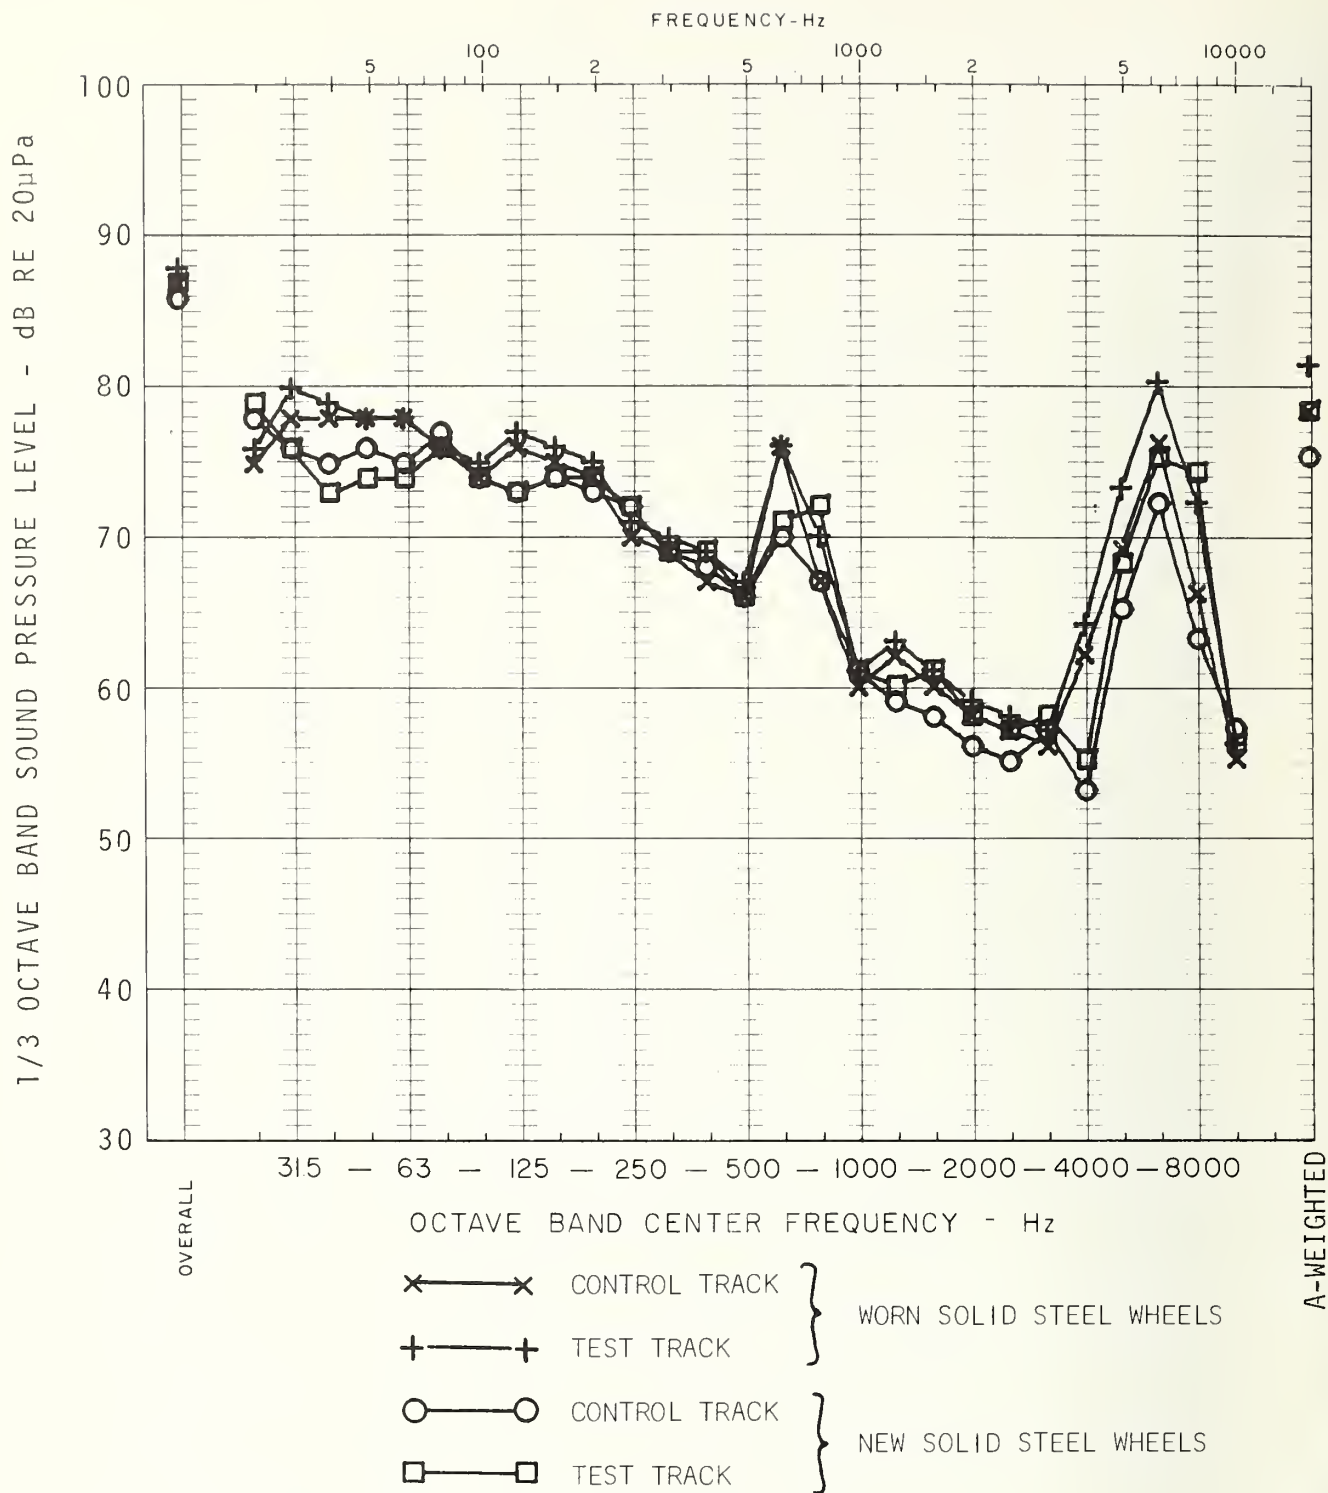
FIGURE B-1. SHORT RADIUS CURVE AT 69TH STREET TURNAROUND  
 PHASE IB; AUGUST 18, 1976  
 ENERGY AVERAGE OF ALL TESTS  
 CAR INTERIOR NOISE - OVER TRUCK

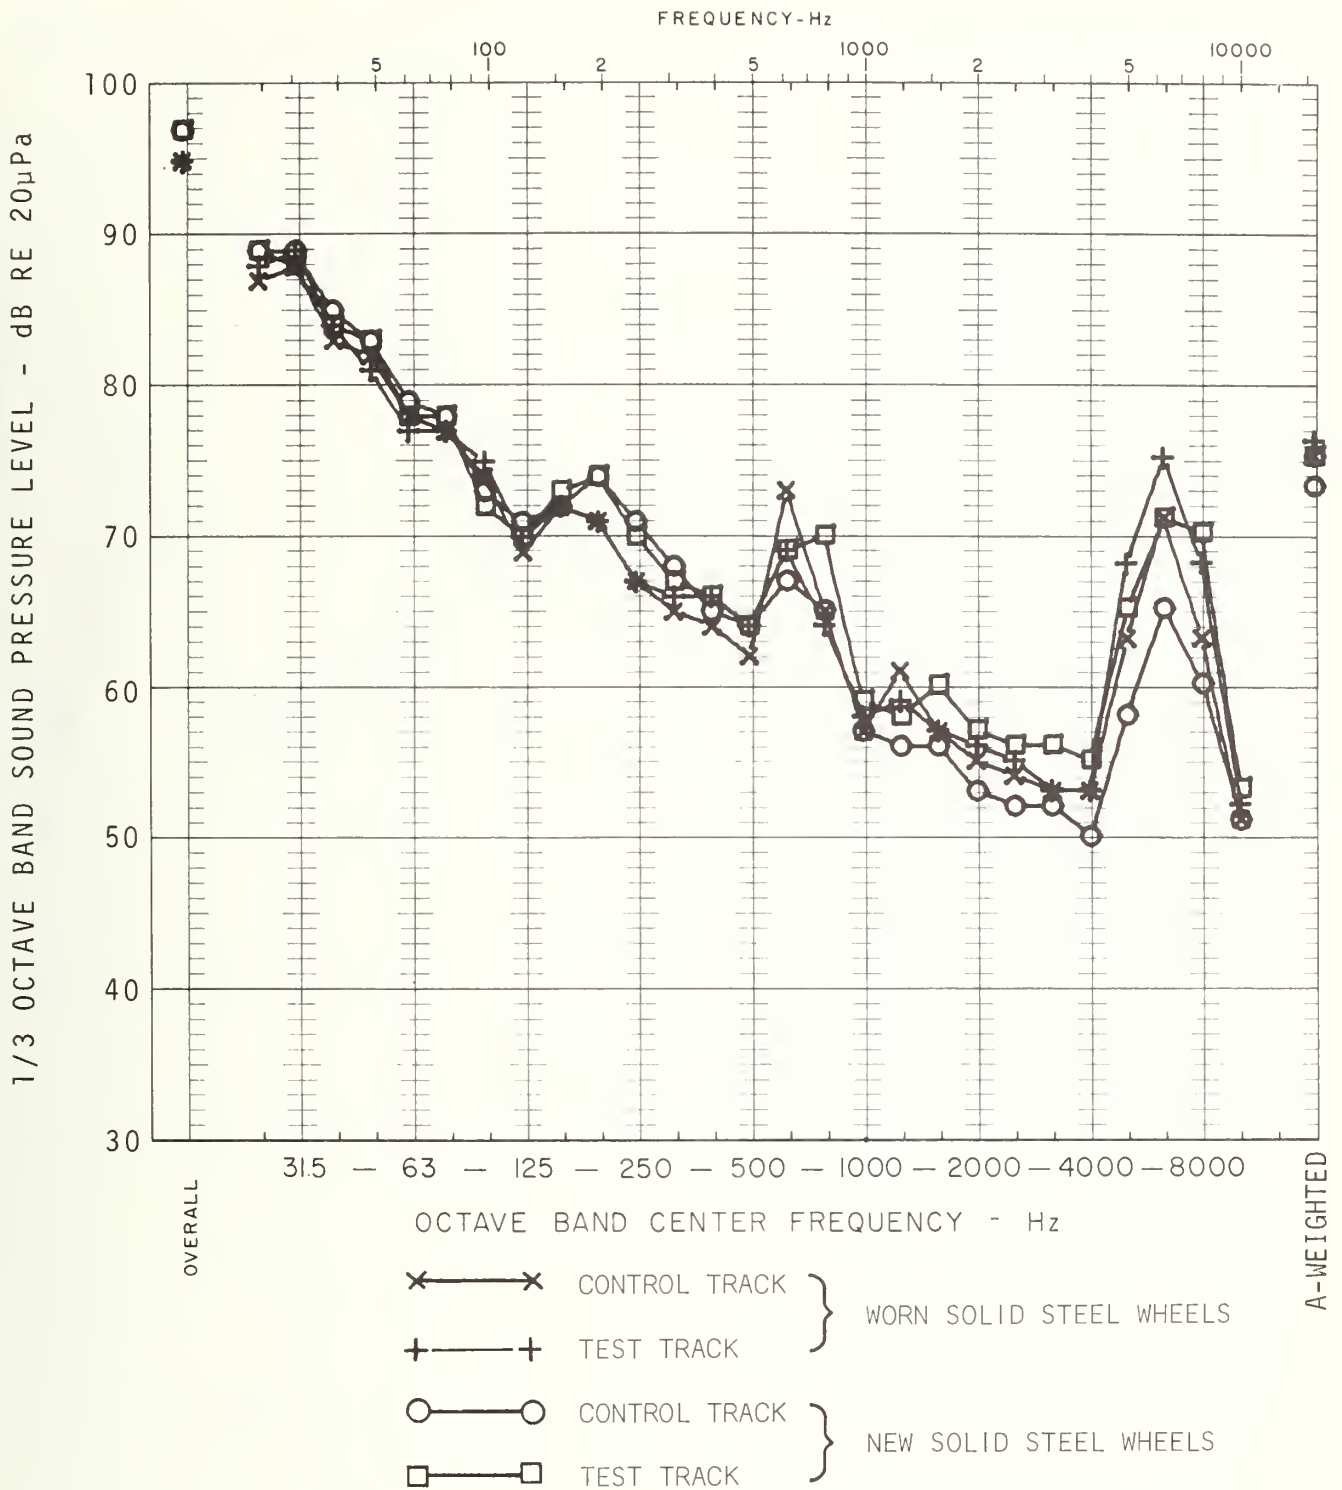
FIGURE B-2. SHORT RADIUS CURVE AT 69TH STREET TURNAROUND  
 PHASE IB; AUGUST 18, 1976  
 ENERGY AVERAGE OF ALL TESTS  
 CAR INTERIOR NOISE - CAR CENTER

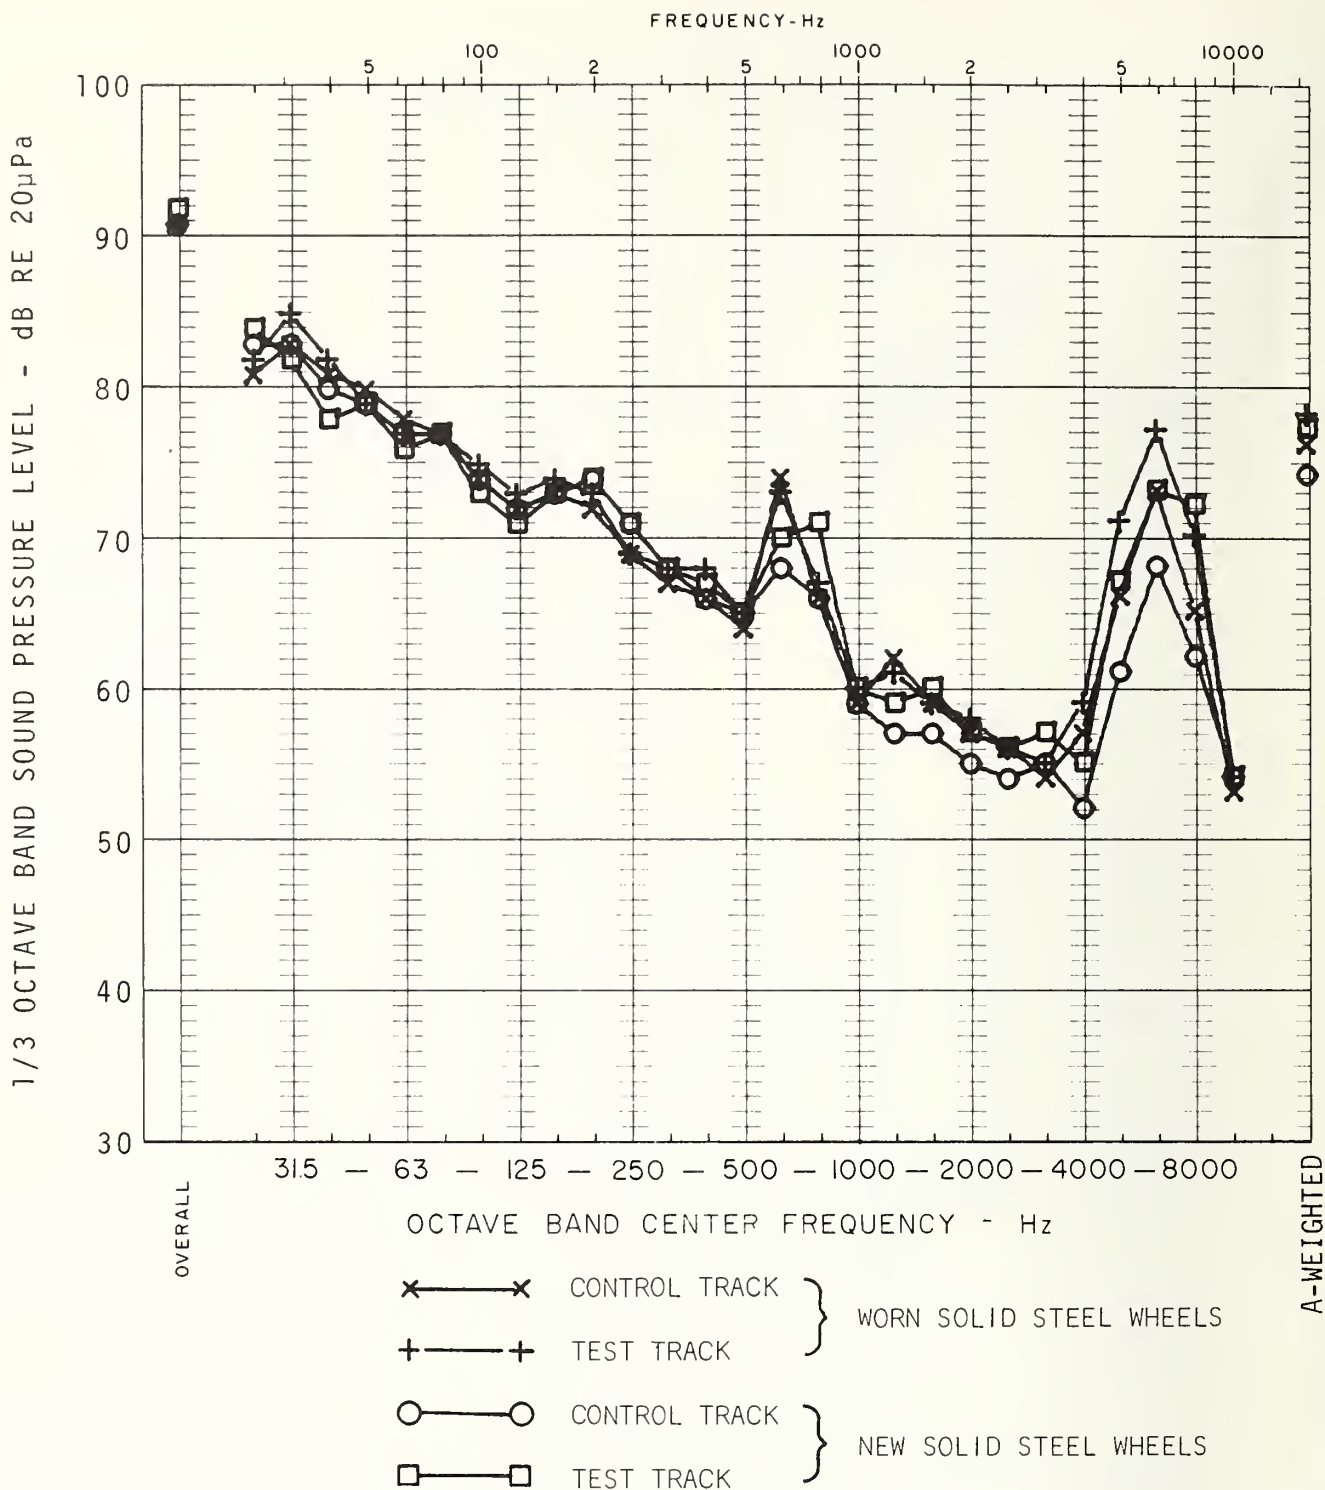
FIGURE B-3. SHORT RADIUS CURVE AT 69TH STREET TURNAROUND  
 PHASE IB; AUGUST 18, 1976  
 AVERAGE OF ALL TESTS [ENERGY] AND BOTH MEASUREMENT  
 LOCATIONS [LINEAR] - CAR INTERIOR NOISE

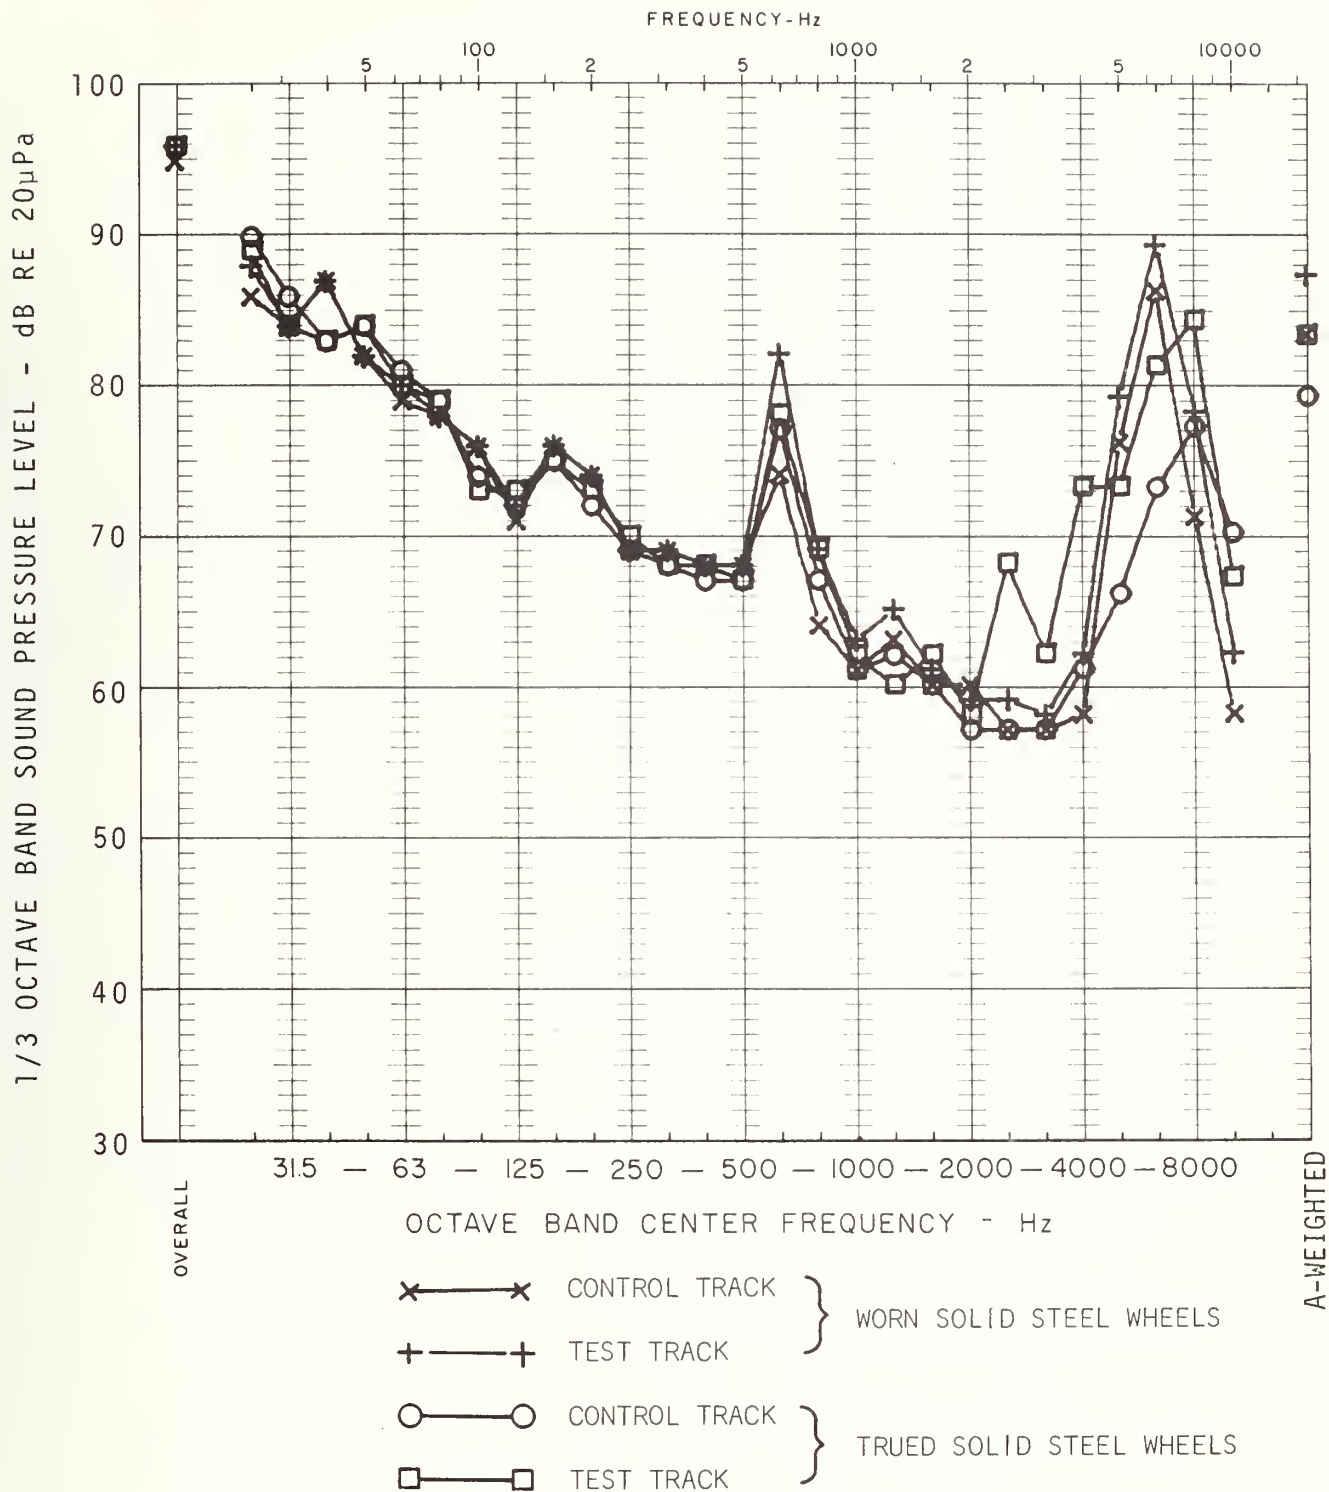
FIGURE B-4. SHORT RADIUS CURVE AT 69TH STREET TURNAROUND  
 PHASE IC; SEPTEMBER 1, 1976  
 ENERGY AVERAGE OF ALL TESTS  
 CAR INTERIOR NOISE - OVER TRUCK

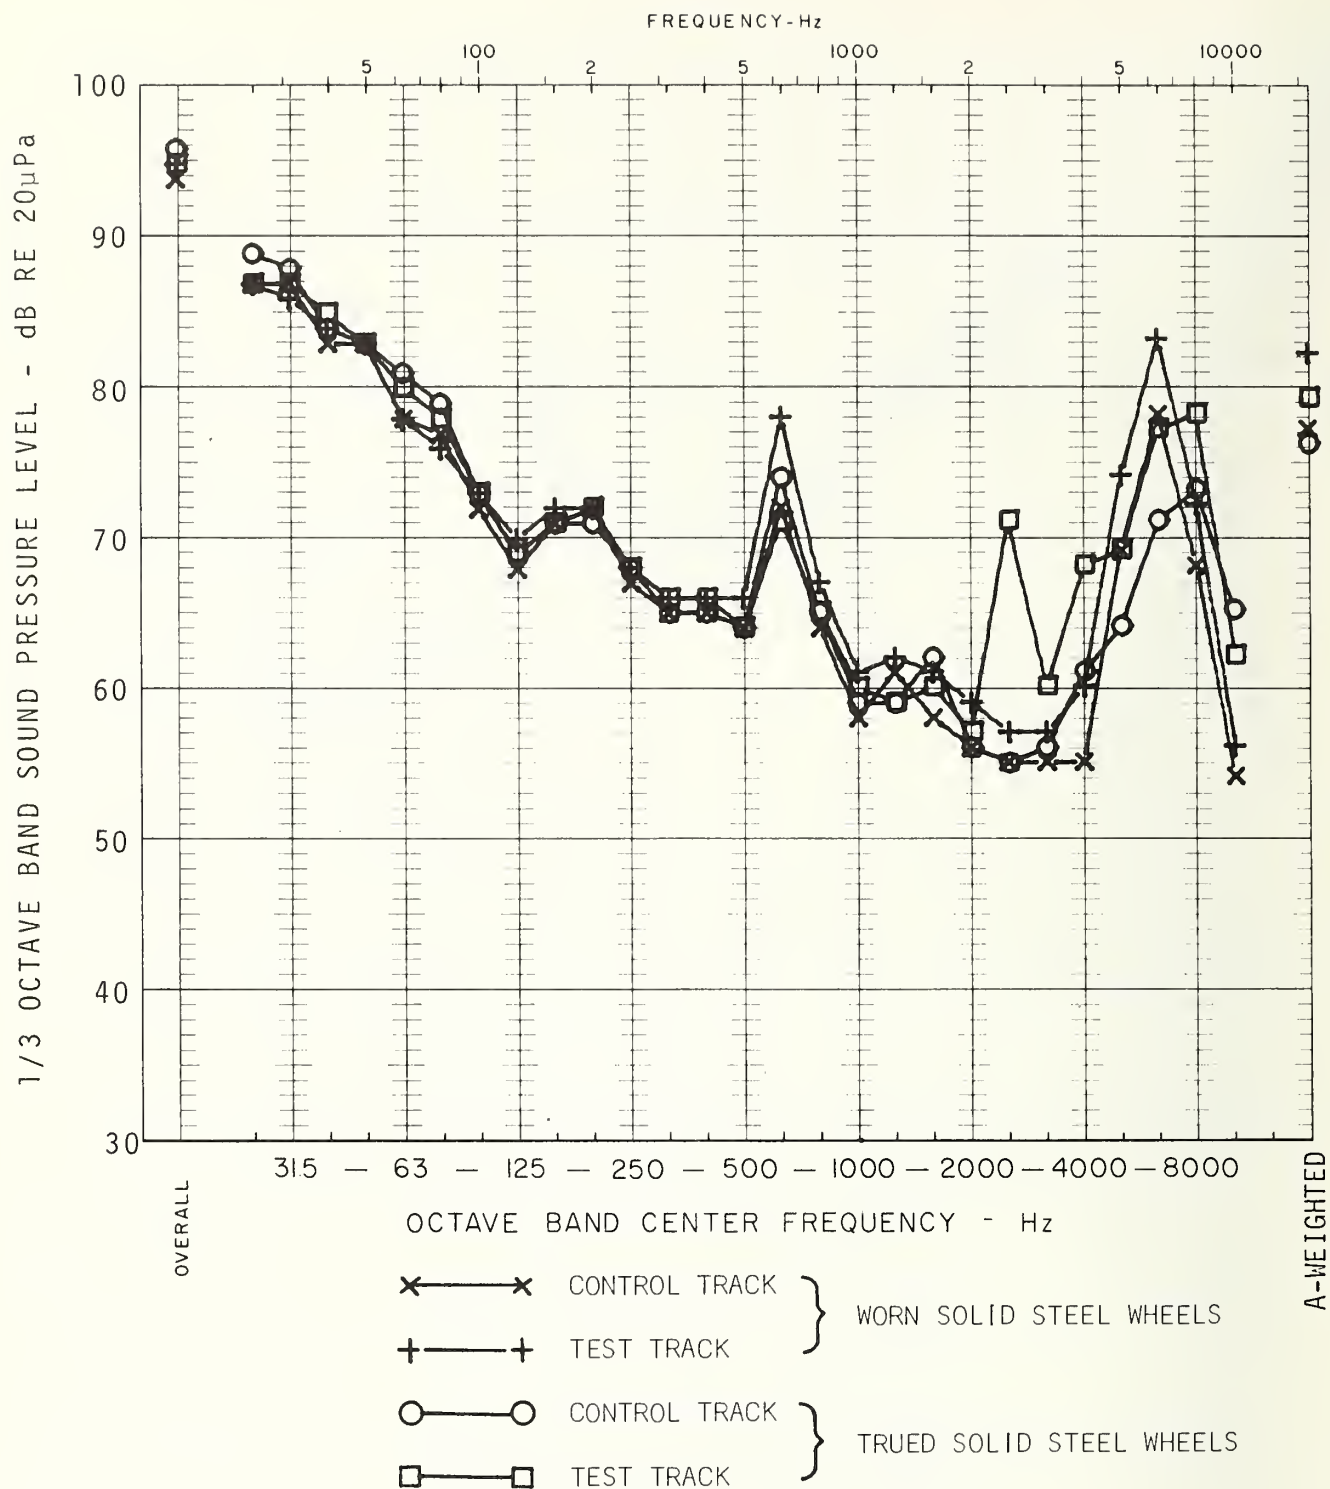
FIGURE B-5. SHORT RADIUS CURVE AT 69TH STREET TURNAROUND  
 PHASE IC; SEPTEMBER 1, 1976  
 ENERGY AVERAGE OF ALL TESTS  
 CAR INTERIOR NOISE - CAR CENTER

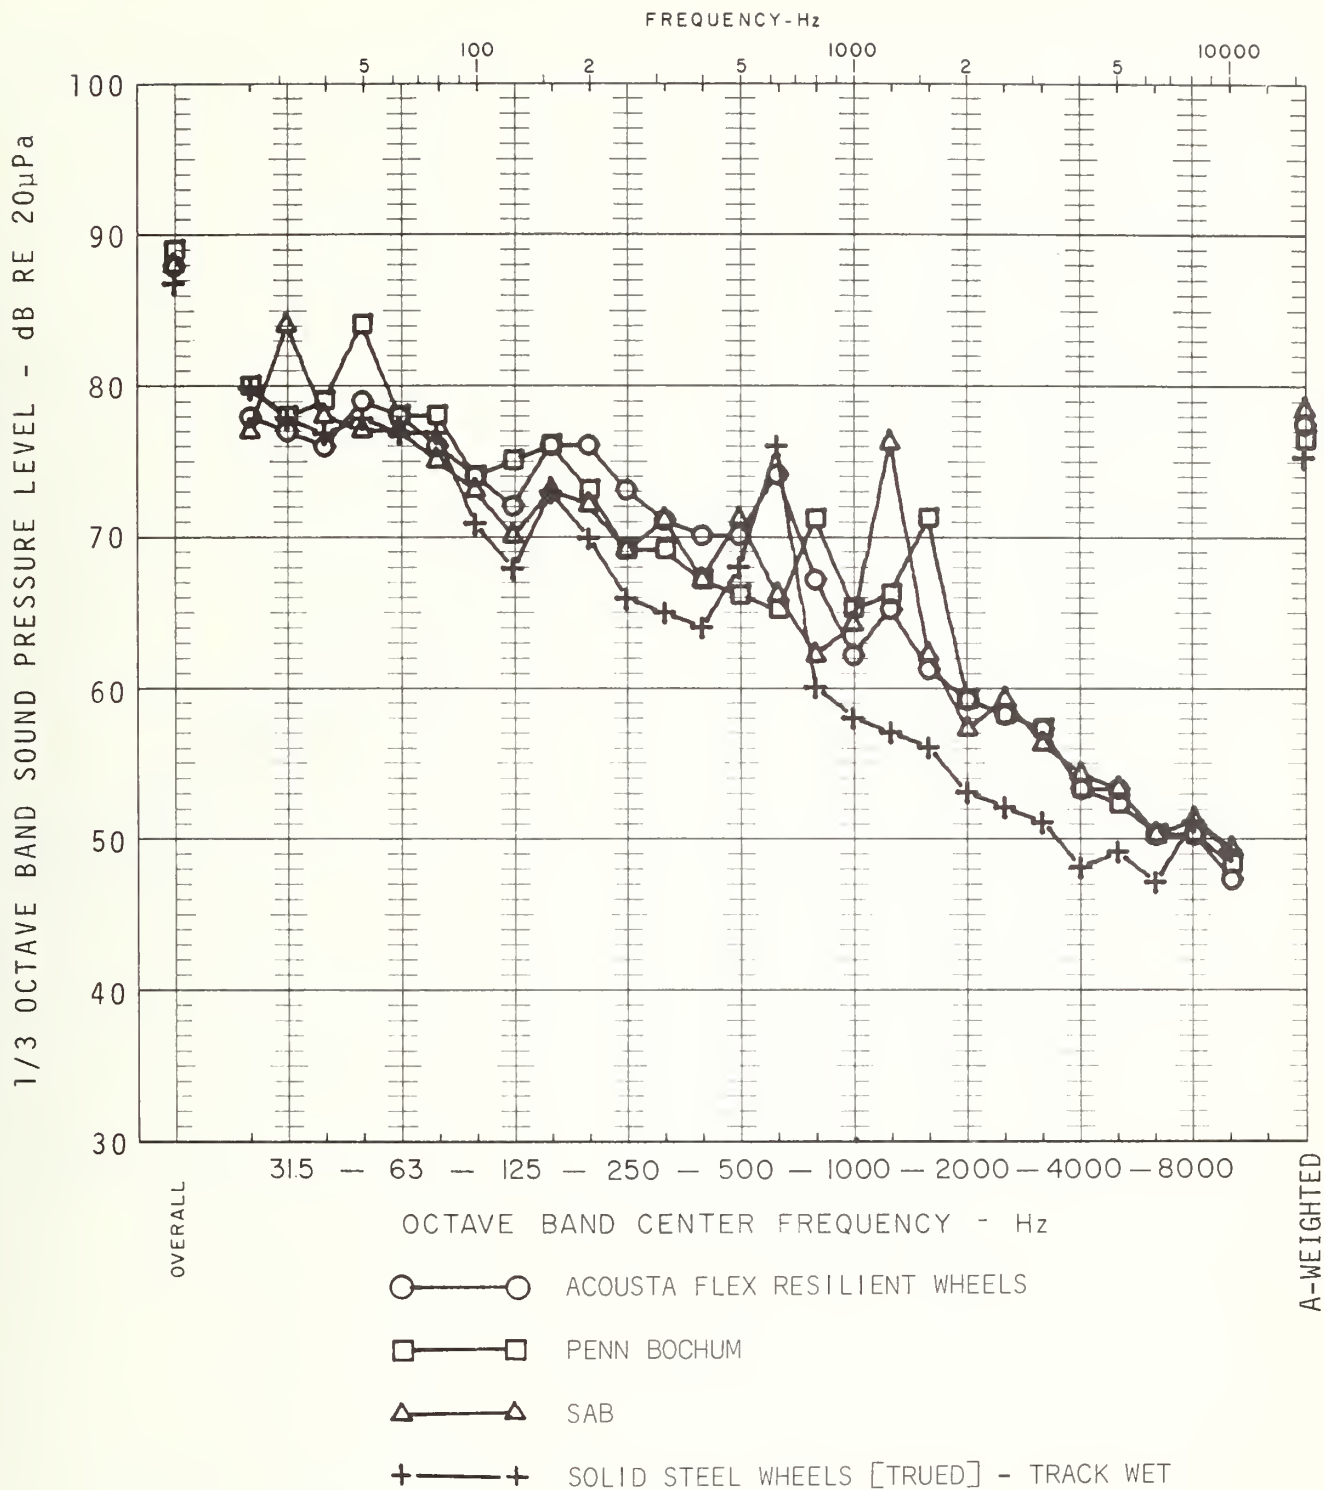
FIGURE B-6. SHORT RADIUS CURVE AT 69TH STREET TURNAROUND  
 PHASE IIA; OCTOBER 3, 1976  
 ENERGY AVERAGE OF ALL TESTS ON CONTROL TRACK SEGMENT  
 CAR INTERIOR NOISE - OVER TRUCK

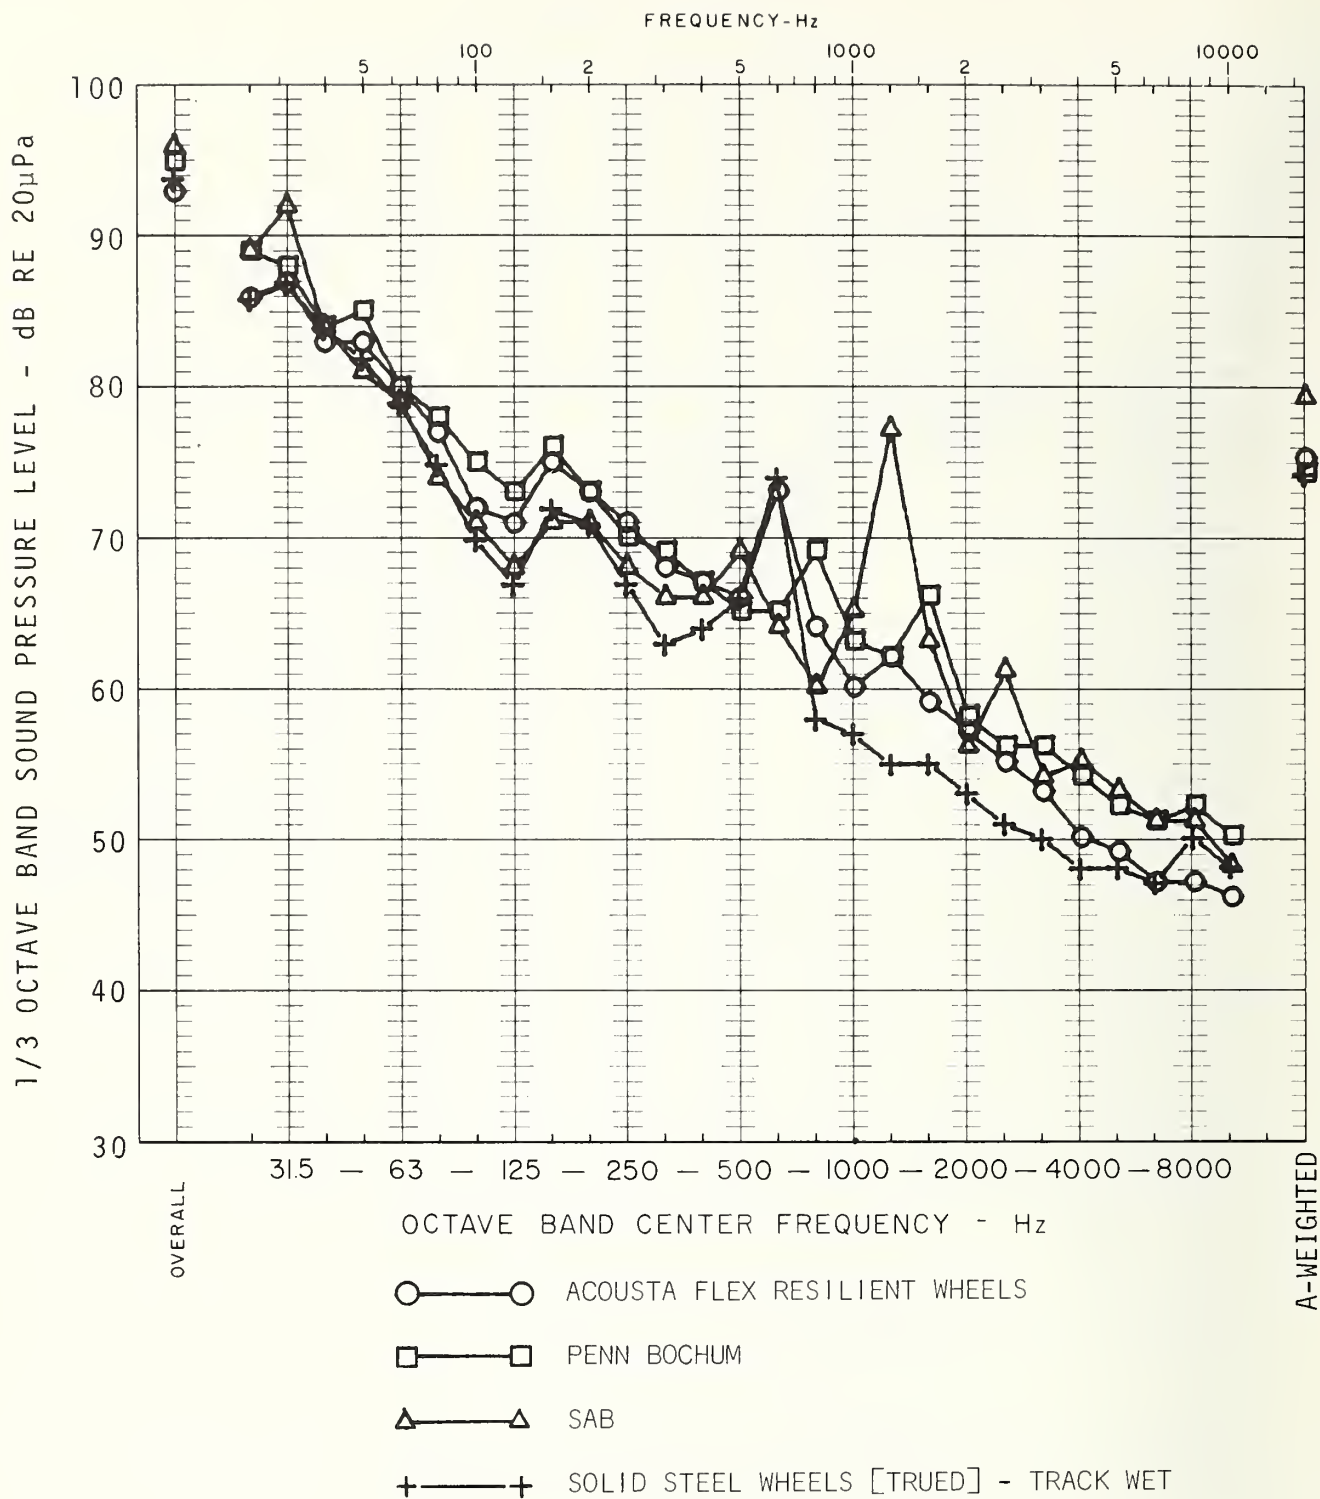
FIGURE B-7. SHORT RADIUS CURVE AT 69TH STREET TURNAROUND  
 PHASE IIA; OCTOBER 3, 1976  
 ENERGY AVERAGE OF ALL TESTS ON CONTROL TRACK SEGMENT  
 CAR INTERIOR NOISE - CAR CENTER

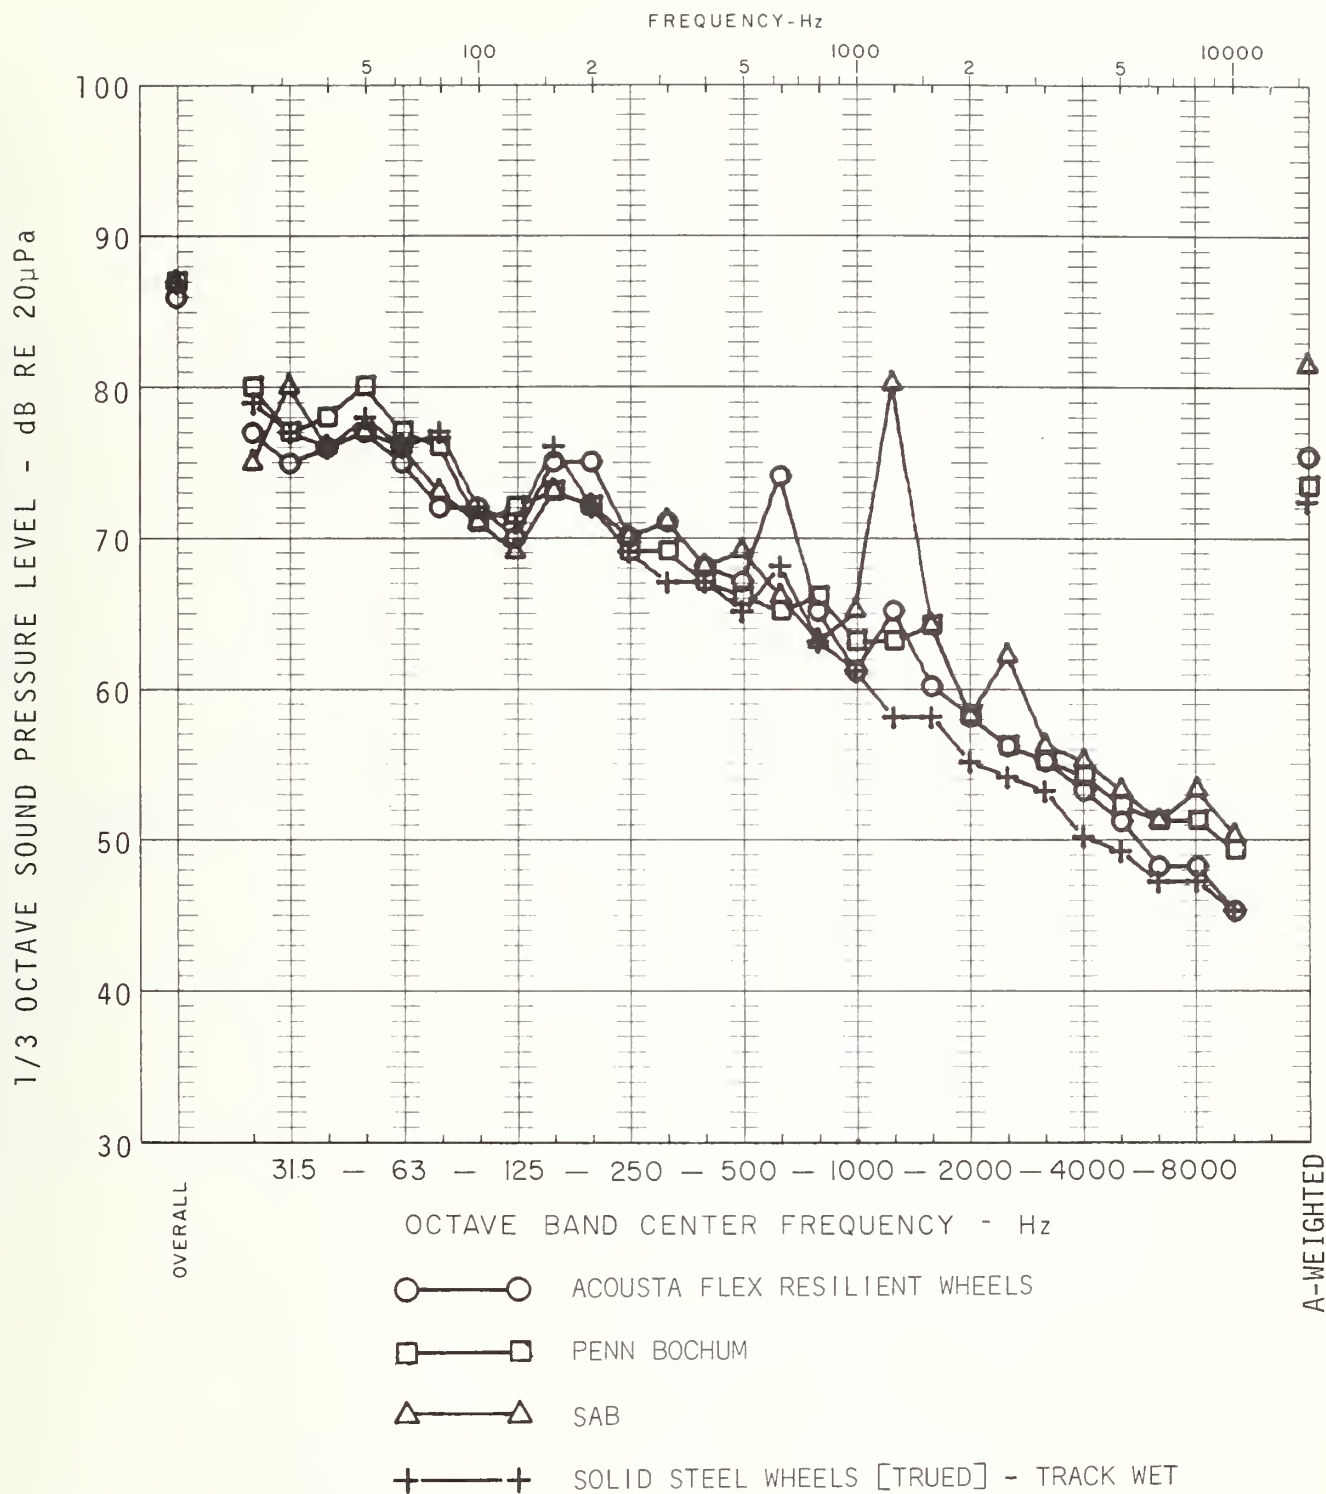
FIGURE B-8. SHORT RADIUS CURVE AT 69TH STREET TURNAROUND

CAR INTERIOR NOISE - OVER TRUCK

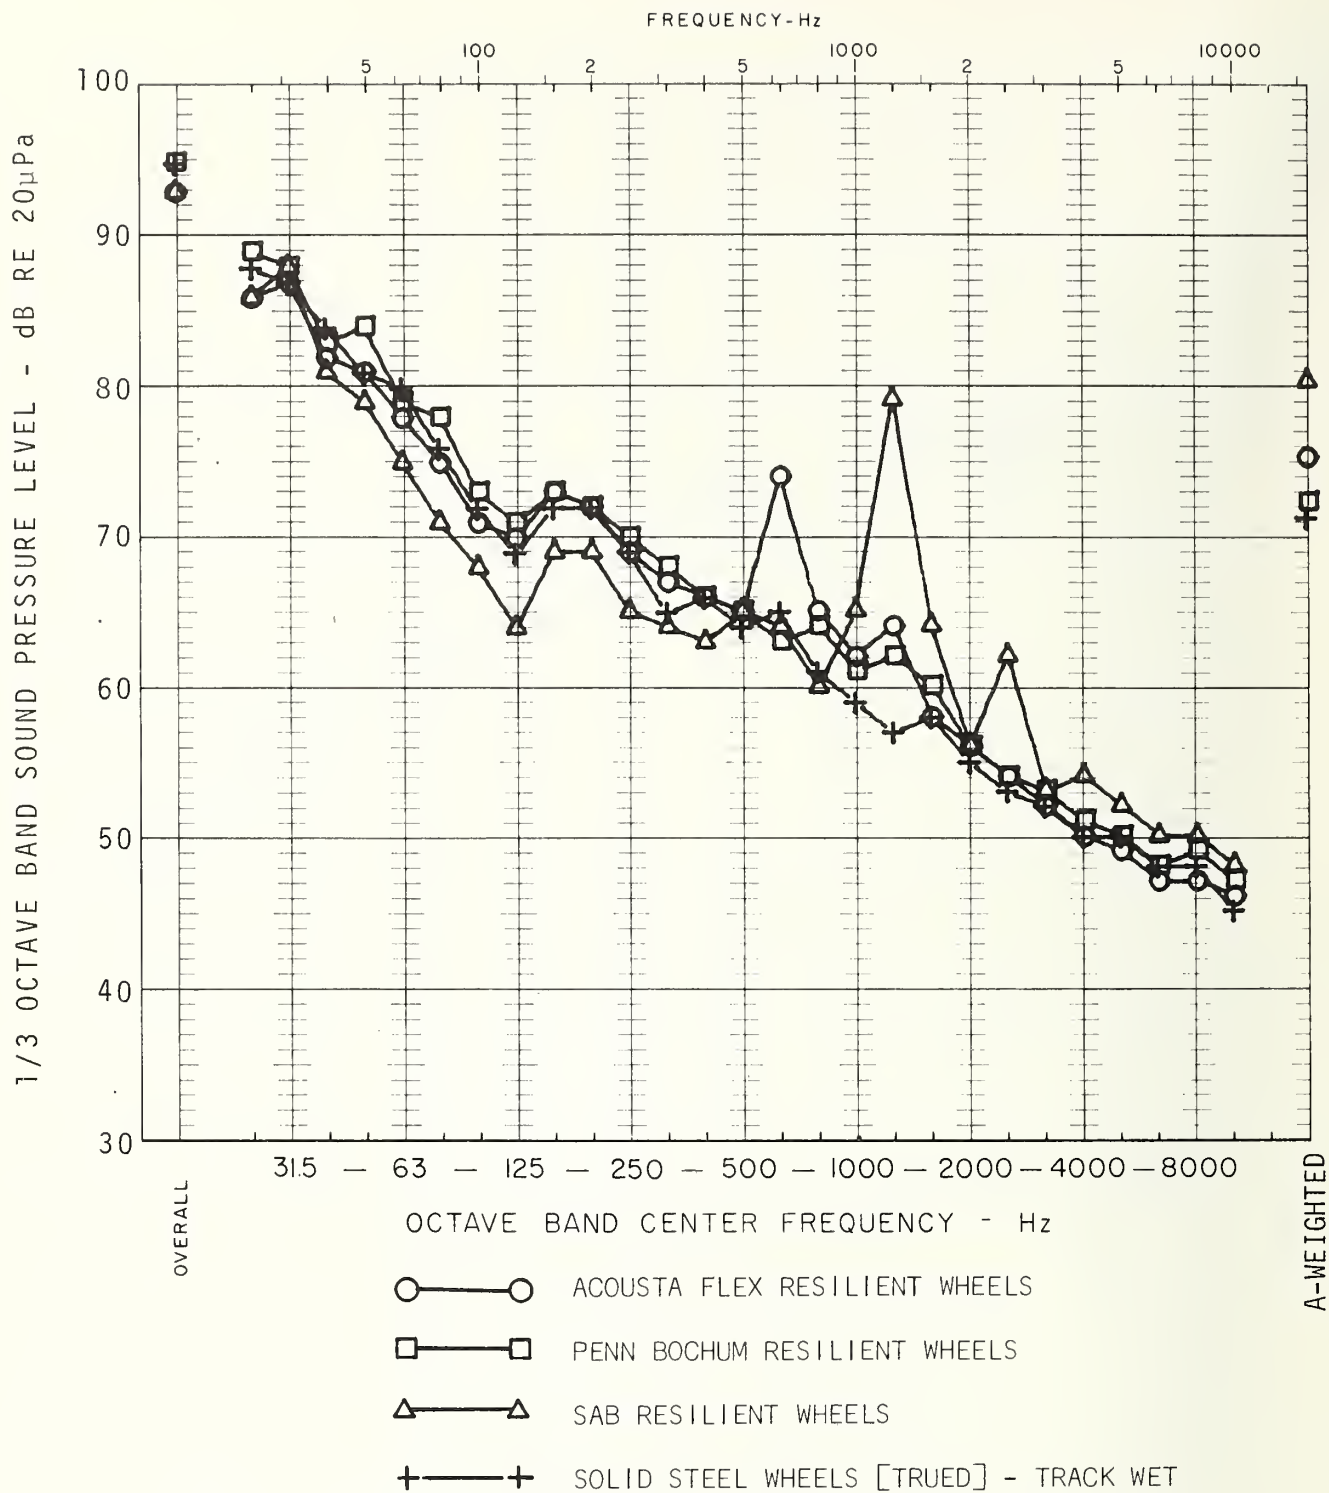
FIGURE B-9. SHORT RADIUS CURVE AT 69TH STREET TURNAROUND  
 PHASE IIA; OCTOBER 3, 1976  
 ENERGY AVERAGE OF ALL TESTS ON TEST TRACK SEGMENT  
 CAR INTERIOR NOISE - CAR CENTER
